2.1 Appendix A: Exterior Hard Wall Containment Barrier Option 1

Exterior Hard Wall Containment Barrier Option #1

130 CEDAR STREET

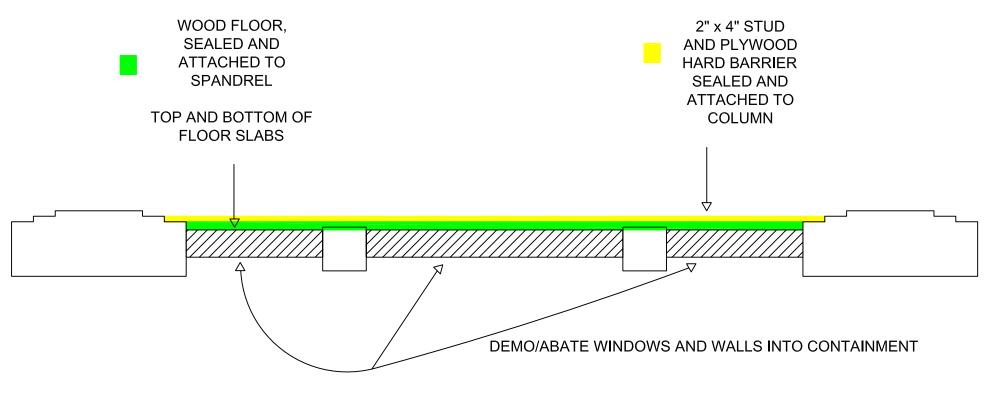
EXTERIOR WALL CONTAINMENT BARRIER OPTIONS #1, #1A & #1B

#1A - CONSTRUCTED AS SEEN ABOVE WITH ADDITIONAL SUPPORTS ON THE EXTERIOR SURFACE OF THE SPANDREL WALL

#1B - THE BOTTOM OF THE HARD BARRIER CONTAINMENT WILL BE SEALED AT CAST CONCRETE CAP OF THE SPANDREL WALL

Option #1

This option for construction of an exterior hard walled containment barrier will be utilized when there is an exterior breach in the two wall unit spandrel wall and the brick cladding on the columns on either side of the bay are intact. A double six mil poly covered plywood barrier will be anchored to the brick cladding on each side of the bay, column to column and on the top and bottom of the barrier, from slab to slab. Caulking and foam will be utilized as necessary to seal this barrier. A foam sealed plywood insert will be installed at the top and the bottom of this barrier to seal the set back from the column brick cladding to the slab brick cladding. The windows, window caulking and the two wall unit spandrel walls will be abated and demolished into the building/containment.

Option #1A

Where there is no breach in the exterior of the spandrel wall, the brick cladding on the columns are intact and the inside of the spandrel walls exhibit manmade openings, a hard walled containment as in Option #1 will be erected. Additionally in this option, a plywood and wooden stud support will also be anchored up against the exterior of the brick cladding of the spandrel wall. This support will allow for the interior clay wall to be abated and demolished into the building/containment. In the case of a manmade

Option #1B

Where there are no breaches in the two wall unit spandrel wall, and the brick cladding is in tact on the columns, a double six mil poly covered plywood barrier will be anchored to the brick cladding on each side of the bay, column to column, and on the top of the barrier at the floor slab above and on the bottom at the stone cap supporting the window sitting on top of the two wall spandrel unit. The containment will allow for the windows and window caulking to be abated/demolished into the building/containment. Subsequent to the window/window caulking abatement and as part of the floor/containment abatement, the interior spandrel wall surface will be cleaned and encapsulated. The exterior surface would have been cleaned as part of the Building Façade Clean-up in Phase I A & B. The cleaned two wall spandrel unit and the stone cap will be left for demolition during the selective demolition phase.

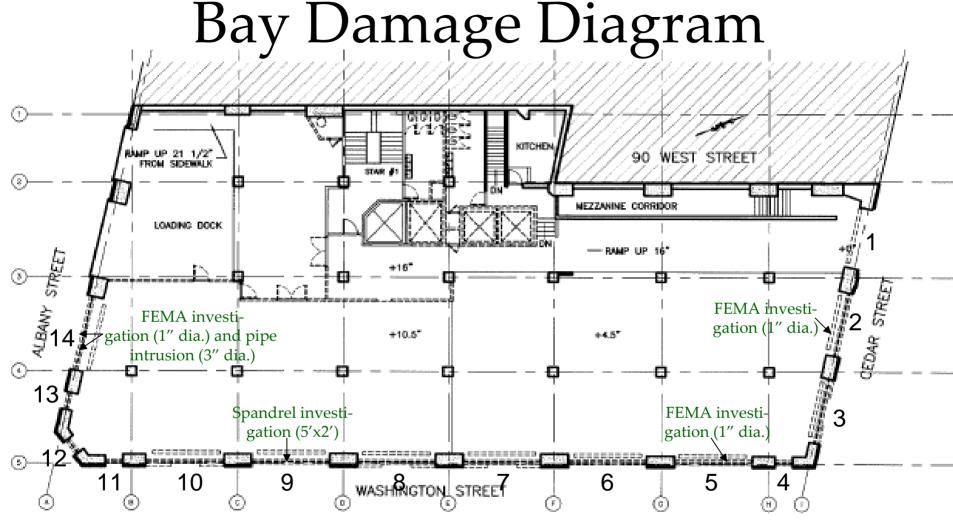
Ground Floor

NOTE: FEMA Investigation refers to 1" dia. drill holes on interior spandrel wall

Spandrel Investigation refers to previous spadnrel wall investigations on interior spandrel wall

Other notes located in the interior portion of the floorplan refer to all other interior breaches and are described in the diagram

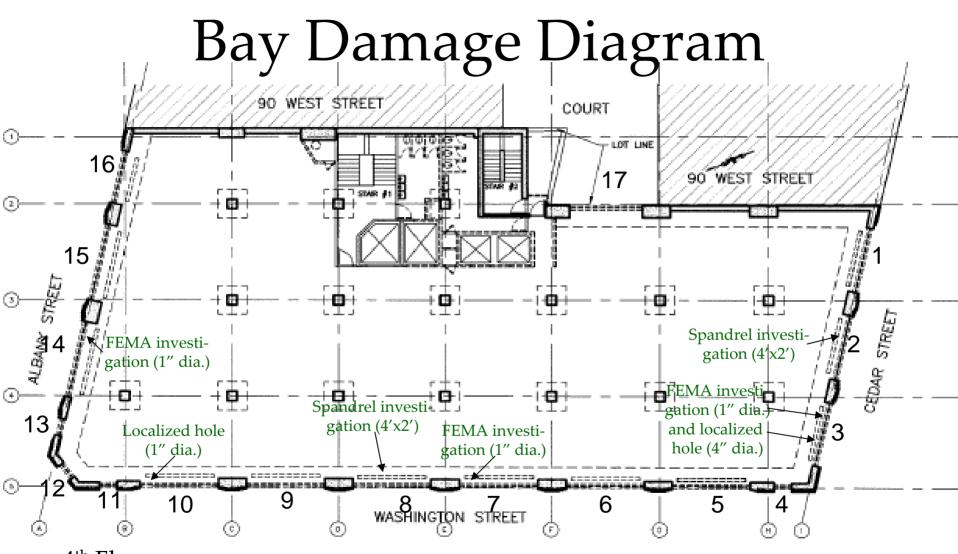
4th Floor

NOTE: FEMA Investigation refers to 1" dia. drill holes on interior spandrel wall

Spandrel Investigation refers to previous spandrel wall investigations on interior spandrel wall

Other notes located in the interior portion of the floorplan refer to all other interior breaches and are described in the diagram
